Chapter 3

PERFORATING MACHINES

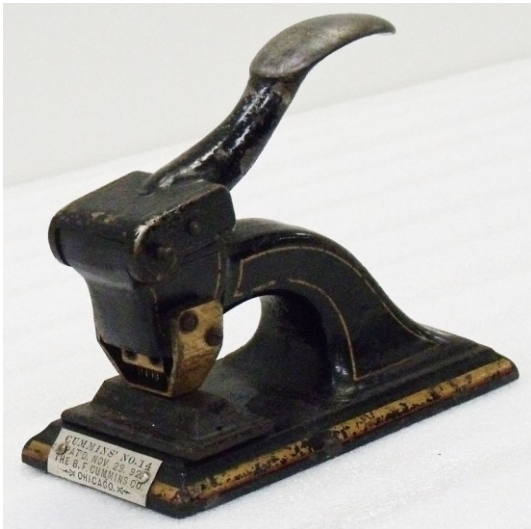
Cummins Model 14

only single die perforator known to exist is that of the Ogilvie Flour Mills Company, Winnipeg (04) which is a Cummins Model 14. The Cummins Perforator Company specifications for this machine have not been located.

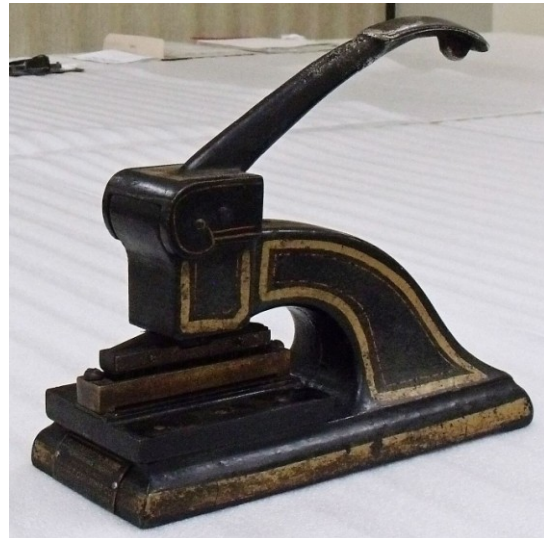
Cummins Model 52

The machine that has had the widest distribution in Canada is Model 52 from the B.F. Cummins Perforator Company of Chicago, Illinois. This machine has a width to accommodate a row of five regular sized (George V Admiral) stamps which necessitates a sheet of stamps being folded or separated in half prior to the perforating operation. These groups of pins forming the set of initials are so spaced that when one-half sheet of regular sized stamps are perforated, the design appears in the center of each stamp. It is common, therefore, to find more recent stamps with their varying sizes having split or off-center perforations and, of course, double-sized stamps will contain part of an extra set of initials, or two sets due to the width of the stamp.

Model 52 shown above has a base measuring 12½" x 5" and weighs 23 pounds. The base is made of cast iron while the balance of the machine is steel. The listed capacity by B.F. Cummins is as follows:

*Three or less initials on each stamp – four sheets thick
(20 stamps at each stroke, row of 5)*

*Four initials on each stamp – three sheets thick
(15 stamps at each stroke, row of 5).*

*Five or six initials on each stamp – two sheets thick
(10 stamps at each stroke, row of 5)*

Stamps can be perforated at the rate of 300 to 500 per minute.

The Cummins Model 52, if a folded sheet was fed into it could produce mirror pairs with one position being the normal and the other reversed. These pairs are scarce, as they are usually separated when applied to the mail.
